USE OF THERMAL IMAGING METHOD OF CONTROL FOR INSPECTION OF BUILDING STRUCTURES FOR TIGHTNESS

Thermal inspection of window structures of a residential building

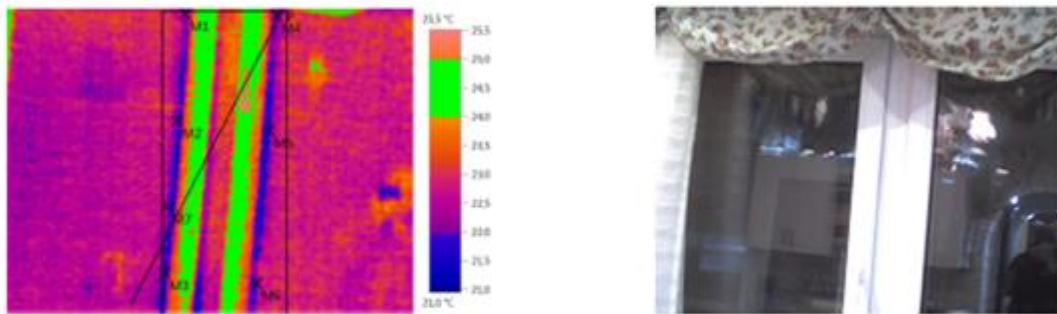
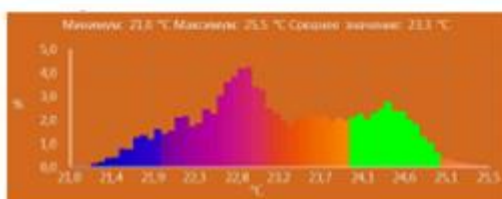
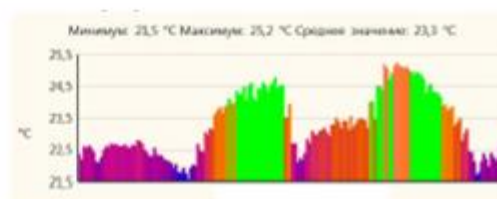
Figure 3: Analysis of the conducted thermal imaging inspection of the apartment window units

- the presence of voids (under the sill) was revealed;
- defects in filling the installation gaps during the construction of joints;
- thermal imaging inspection revealed air leakage both from the inside of the premises and from the outside;
- traces of condensation and mold formation on the slopes were revealed.

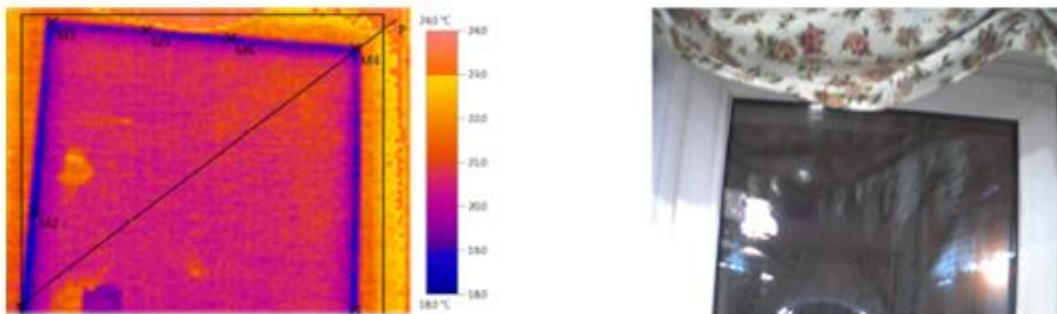
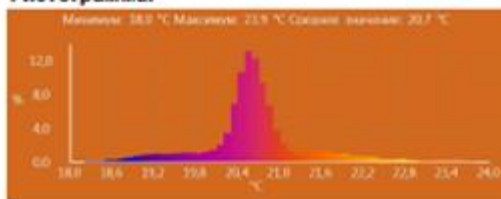
Figure 4: Analysis of the conducted thermal imaging inspection of the balcony door of the apartment

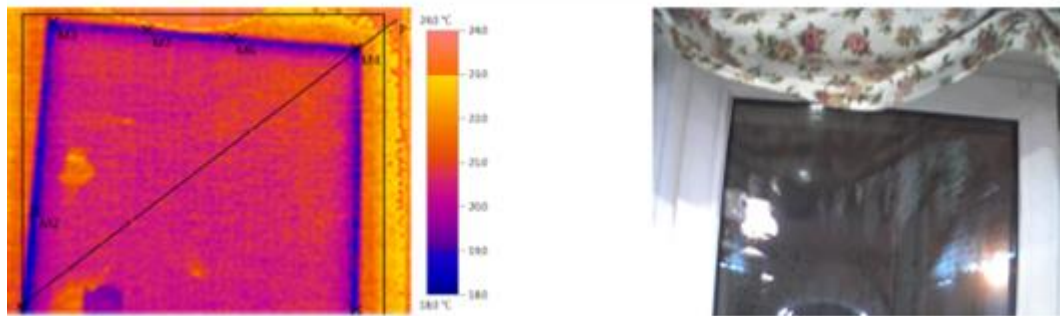
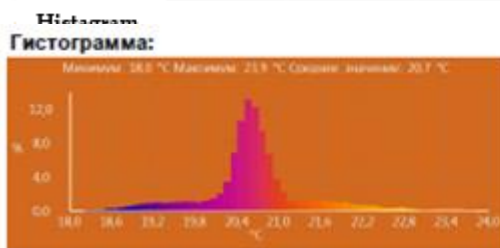
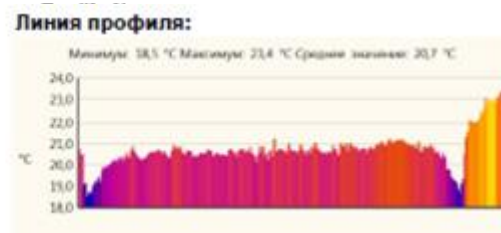
Figure 5: Analysis of the conducted thermal imaging inspection of the apartment window units

The reason of occurrence of available defects and shortcomings is low quality of manufacture of products and their installation. Translucent structures made of PVC profile installed in the apartment do not meet the basic requirement for windows of any design (tightness), it is not possible to use them for their intended purpose (operation) [10].
