ASSESSMENT OF INFRASTRUCTURAL CHANGES IN THE TERRITORIES OF TSKHINVALI REGION OF GEORGIA (2007–2023) USING GEOINFORMATION SYSTEMS

This study examines the spatial and quantitative changes to infrastructure and settlements in the Tskhinvali region of Georgia between 2007 and 2023, caused by armed conflict and prolonged occupation. Using high-resolution aerial imagery, satellite data and geographic information systems (GIS), the research identifies and quantifies infrastructural losses across four municipalities: Tskhinvali, Java, Znauri and Akhagori. Multi-temporal image analysis and digitization were performed using Google Earth Pro and ArcMap software. The results reveal a significant decrease in the number and area of infrastructure objects. Tskhinvali municipality experienced the most pronounced decline, with a 13.4% decrease in building areas and an 18.0% reduction in the number of infrastructure objects. The municipalities of Java and Znauri recorded infrastructure losses of 12.8% and 6.6%, respectively, while Akhagori showed a modest 1.2% reduction. The spatial analysis also revealed patterns of degradation in specific settlements. These findings emphasize the long-lasting ef

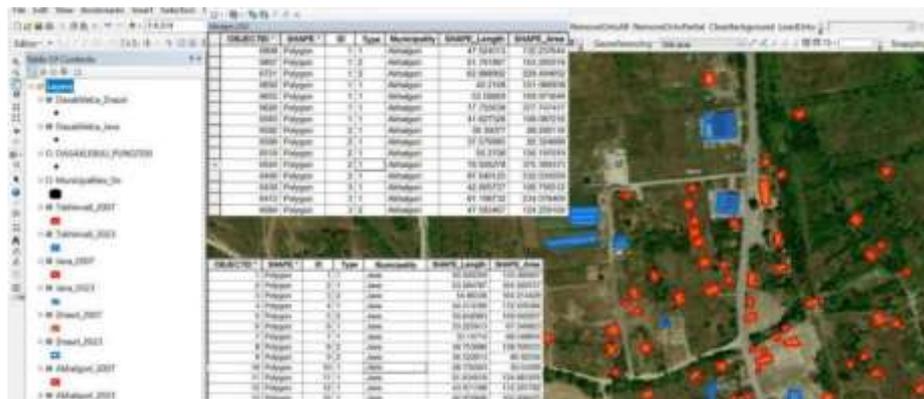
Figure 2: Study area database

Aerial images of different periods and Google Earth Pro software were used as the main base data, where photos of different periods were collected within the study area. The main part included information from the year 2007 and 2023. Digitization of infrastructural objects was carried out using ArcMap software. In the first stage, the photos of 2023 were converted into digital format and grouped according to municipalities. In the next stage, similar activities were conducted based on the data from 2007 [4,14]. In the final stage of the research, the analysis of existing infrastructural objects in the first and second stages in different periods and the preparation of the relevant database were carried out (see Fig. 2).

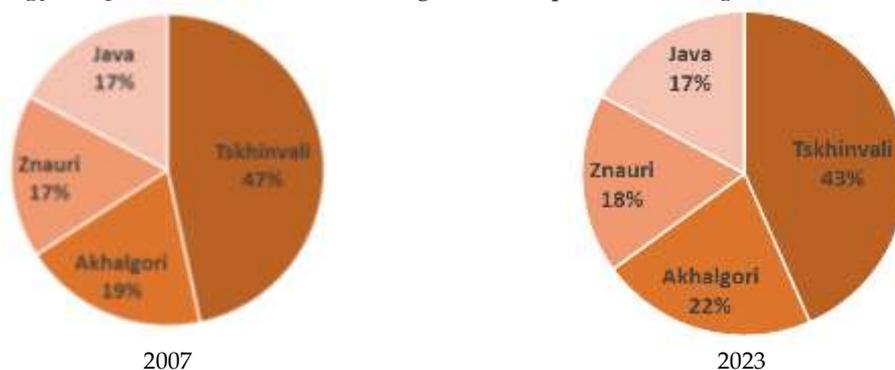
Figure 3: Distribution of infrastructural objects by municipalities (2007-2023)

The results obtained based on the analysis of infrastructural objects using the mentioned methodology are presented below, according to municipalities (see Fig. 3).

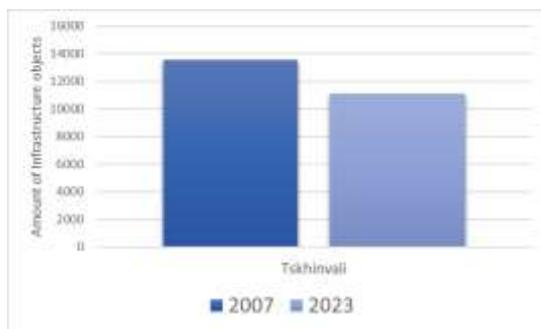
Figure 4: Change in the quantity of infrastructural objects in the occupied territory of the Tskhinvali municipality (2007-2023)

Based on the data of 2023 within the study area, it was determined that 11,098 different types of infrastructural objects were quantitatively fixed within the municipality in the mentioned year. Particularly large number of infrastructural facilities are located in the territories of the Tskhinvali city and nearby settlements, such as villages of Tamarasheni, Kurta, Kekhvi, Kemerti, and Eredvi. Regarding the 2007 data, an analysis of aerial imagery from different areas revealed that 13,546 distinct types of infrastructural objects were recorded in the temporarily occupied territory of the municipality. From 2007 to 2023, the number of infrastructure facilities decreased by 18.0% (see Fig. 4).

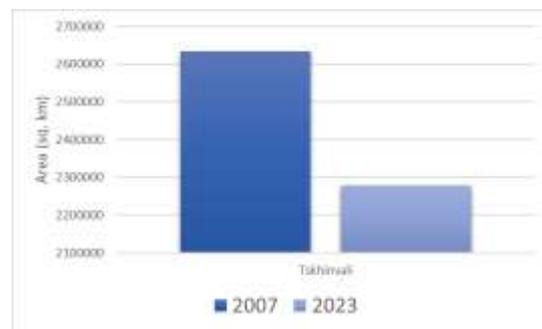
Figure 5: Change of buildings by area in the occupied territory of the Tskhinvali municipality (2007-2023)

The change in the spatial distribution of buildings was also analyzed for the territory of the Tskhinvali municipality. As a result, it was identified that in the period from 2007 to 2023, the areas of buildings in the occupied territory of the municipality decreased by 13.4% (see Fig. 5).

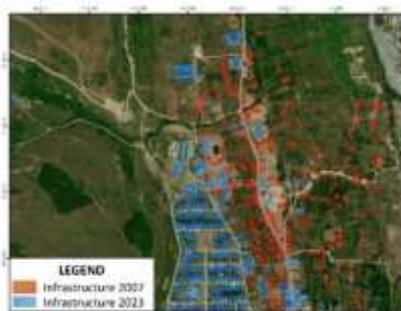
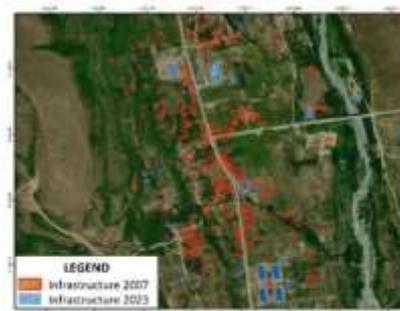
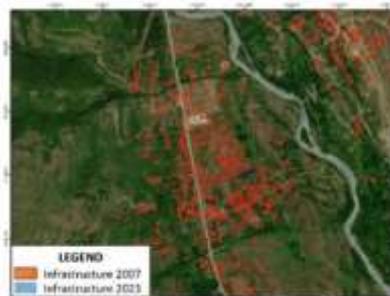
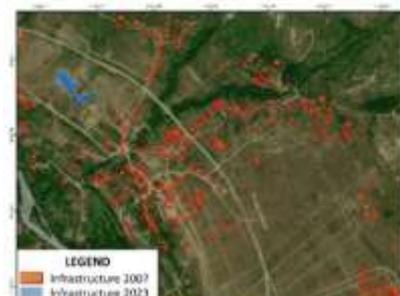
Tamarasheni village (2007-2023)

Zemo Achabeti village (2007-2023)

Kekhvi village (2007-2023)

Kemerti village (2007-2023)

Figure 6. Changes in the quantity and area of several settlements within the Tskhinvali municipality (2007-2023)

Changes in the quantity and area of some settlements within the Tskhinvali municipality are demonstrated below (see Fig. 6).

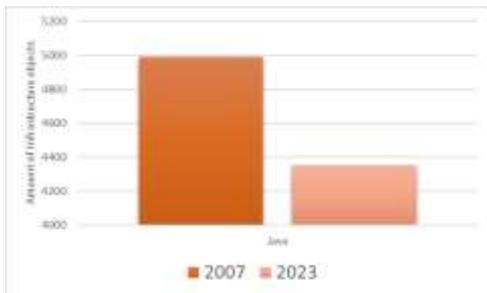
Figure 7: Quantitative change of infrastructural objects in the occupied territory of the Java municipality (2007-2023)

Based on the data of 2023, within the study area, it was determined that 4,353 different types of infrastructural objects were quantitatively recorded within the municipality in the mentioned year. Particularly, a large number of infrastructural facilities are located in the territories of the Java township and nearby settlements - the village of Didi Gupta, Sakire, Mskhlebi, and Buzala. As for the data of 2007, based on the analysis of aerial imagery data of different areas, it was identified that according to the 2007 data, 4,991 different types of infrastructural objects were recorded in the temporarily occupied territory of the municipality. From 2007 to 2023, the number of infrastructure facilities decreased by 12.8% (see Fig. 7).

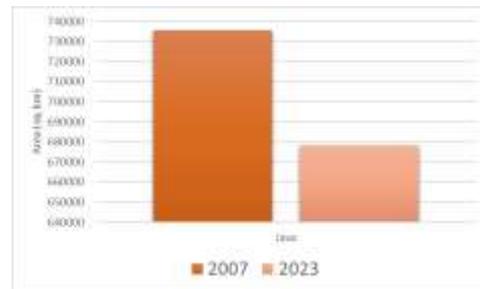
Figure 8: Change of buildings by area in the occupied territory of the Java municipality (2007-2023)

The change in the spatial distribution of buildings was also analyzed for the territory of the Java municipality. As a result, it was identified that in the period from 2007 to 2023, the areas of buildings in the occupied territory of the municipality decreased by 7.8% (see Fig. 8).

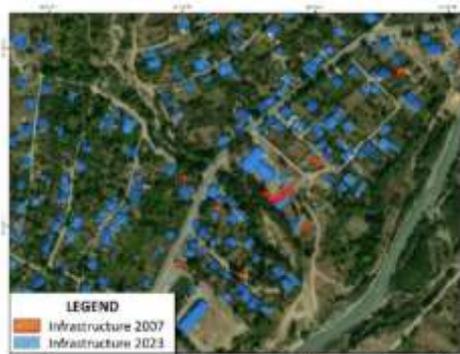
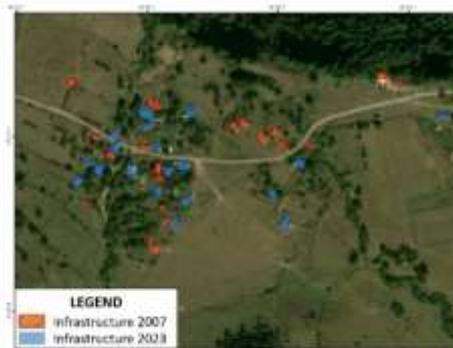
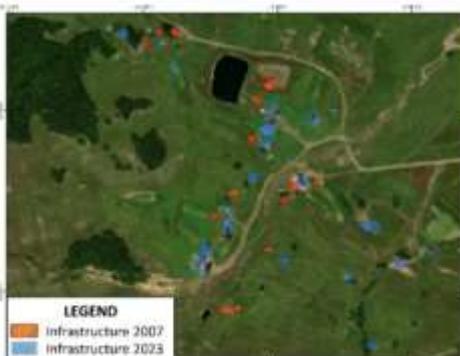
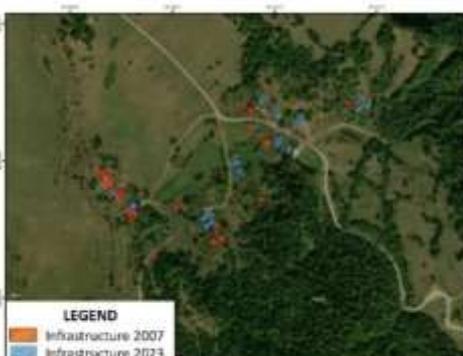
Java township (2007-2023)

Chetari village (2007-2023)

Biteta village (2007-2023)

Tsrui village (2007-2023)

Figure 9: Changes in the quantity and area of several settlements within the Java municipality (2007-2023)

Changes in the quantity and area of several settlements within the Java municipality are demonstrated below (see Fig. 9).

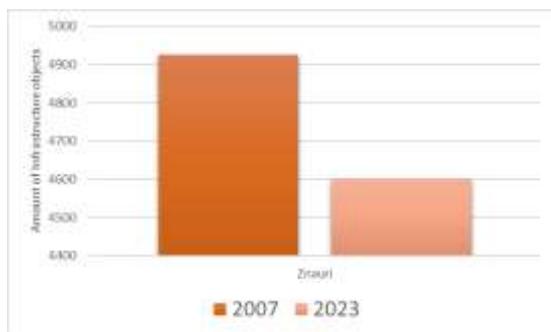
Figure 10: Quantitative change of infrastructural objects in the occupied territory of the Znauri municipality (2007-2023)

Based on the data of 2023 within the study area, it was determined that 4,600 different types of infrastructural objects were quantitatively fixed within the municipality in that year. Particularly large number of infrastructural objects are located in the villages of Kornisi, Avnevi, Didi Tsikhiata, and Akhalsheni. As for the data of 2007, based on the analysis of aerial imagery data of different areas, it was determined that according to the 2007 data, 4,926 different types of infrastructural objects were recorded in the temporarily occupied territory of the municipality. From 2007 to 2023, the number of infrastructure facilities decreased by 6.6% (see Fig. 10).

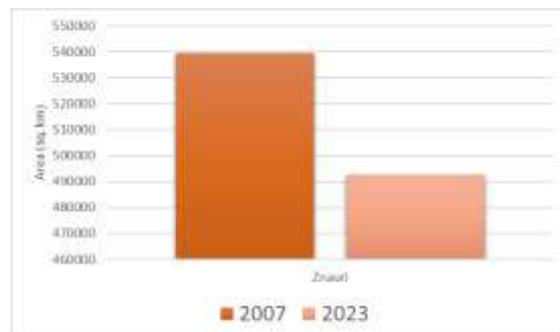
Figure 11: Change of buildings by area in the occupied territory of the Znauri municipality (2007-2023)

The change in the spatial distribution of buildings was also analyzed for the territory of the Znauri municipality. As a result, it was established that in the period from 2007 to 2023, the areas of buildings in the occupied territory of the municipality decreased by 8.7% (see Fig. 11).

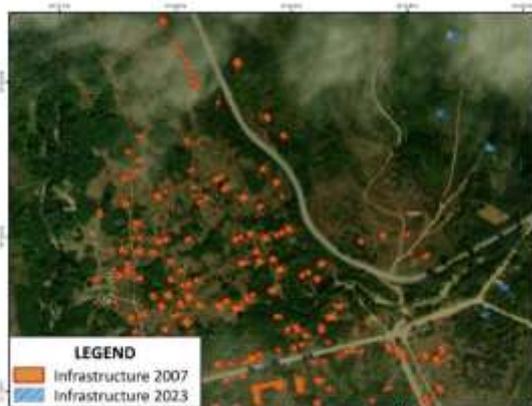
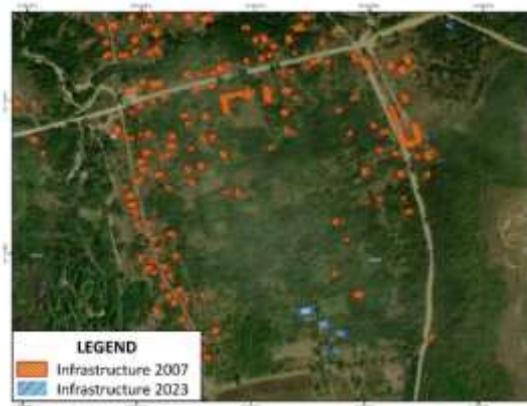
Avnevi village (2007-2023)

Figure 12: Changes in the quantity and area of several settlements within the Znauri municipality (2007-2023)

Changes in the quantity and area of several settlements within the Znauri municipality are demonstrated below (see Fig. 12).

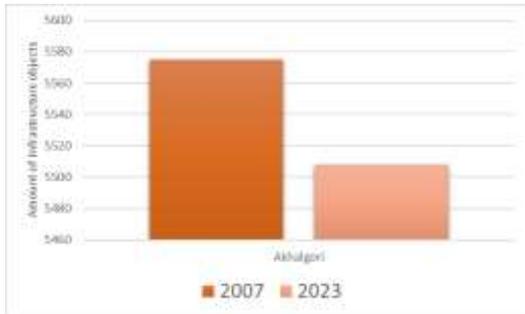
Figure 13: Quantitative change of infrastructural objects in the occupied territory of the Akhagori municipality (2007-2023)

Based on the data of 2023 within the study area, it was determined that 5,508 different types of infrastructural objects were quantitatively recorded within the municipality in the mentioned year. A particularly large number of infrastructural facilities are located in the territory of the Akhalgori city. Regarding the 2007 data, an analysis of aerial imagery from different areas revealed that 5,575 distinct types of infrastructural objects were recorded in the temporarily

occupied territory of the municipality. From 2007 to 2023, the number of infrastructure facilities decreased by 1.2% (see Fig. 13).

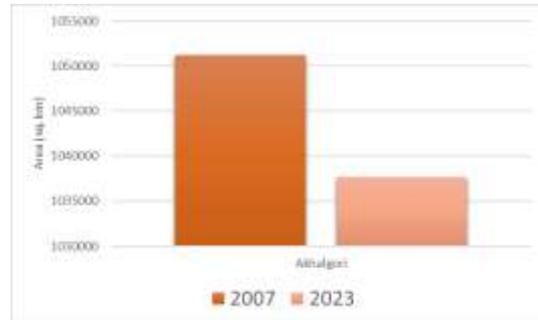
Figure 14: Change of buildings by area in the occupied territory of the Akhagori municipality (2007-2023)

The change in the spatial distribution of buildings was also analyzed for the territory of the Akhagori municipality. As a result, it was determined that the areas of buildings in the occupied territory of the municipality decreased by 1.3% in the period from 2007 to 2023 (see Fig. 14).

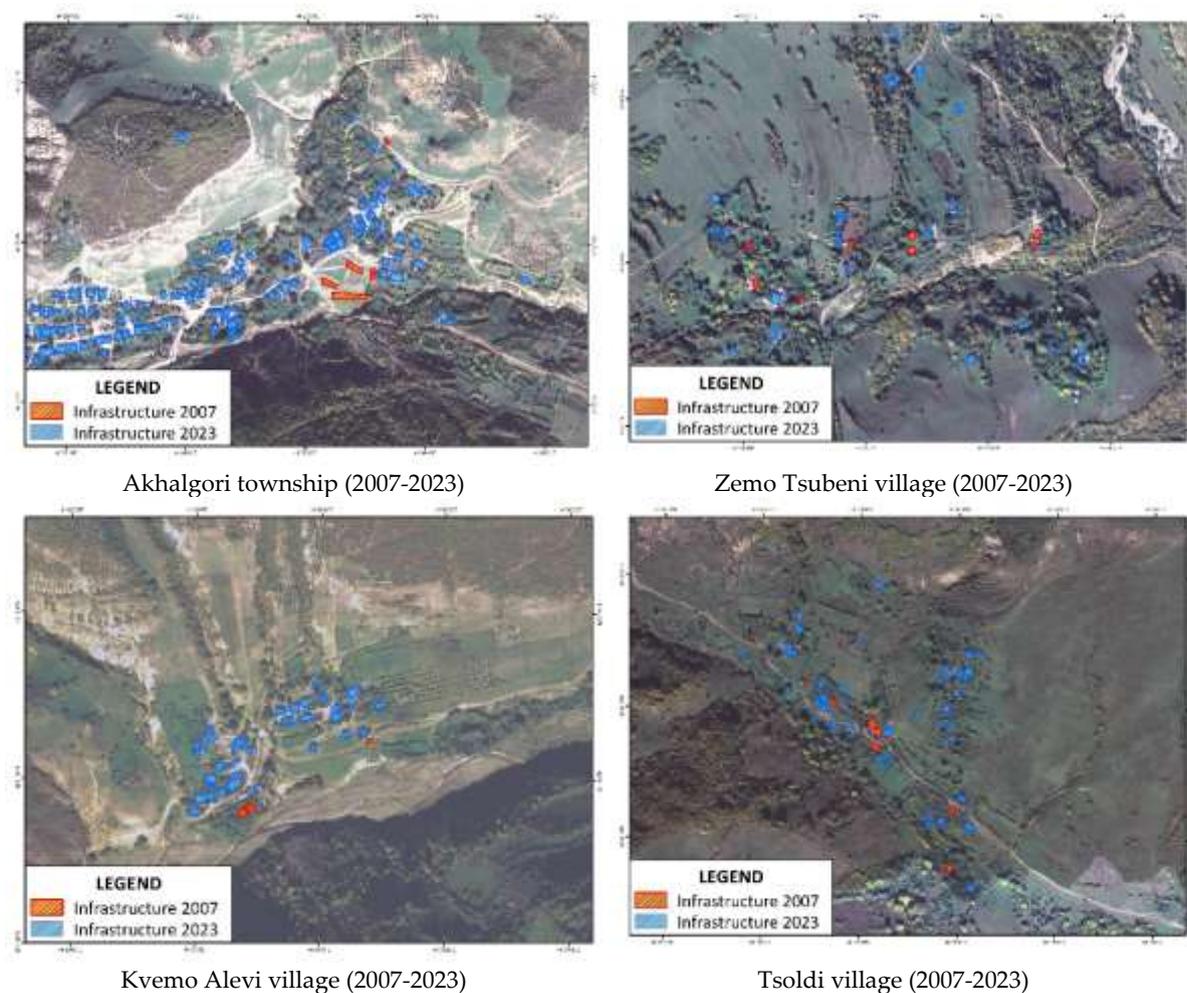
Figure 15: Changes in the quantity and area of several settlements within the Akhagori municipality (2007-2023)

Changes in the quantity and area of several settlements within the Akhagori municipality are demonstrated below (see Fig. 15).
